DOT/FAA/AR-95/51

Nondestructive Inspection of Piper PA-25 Forward Spar Fuselage Attachment Fitting

September 1995

Final Report

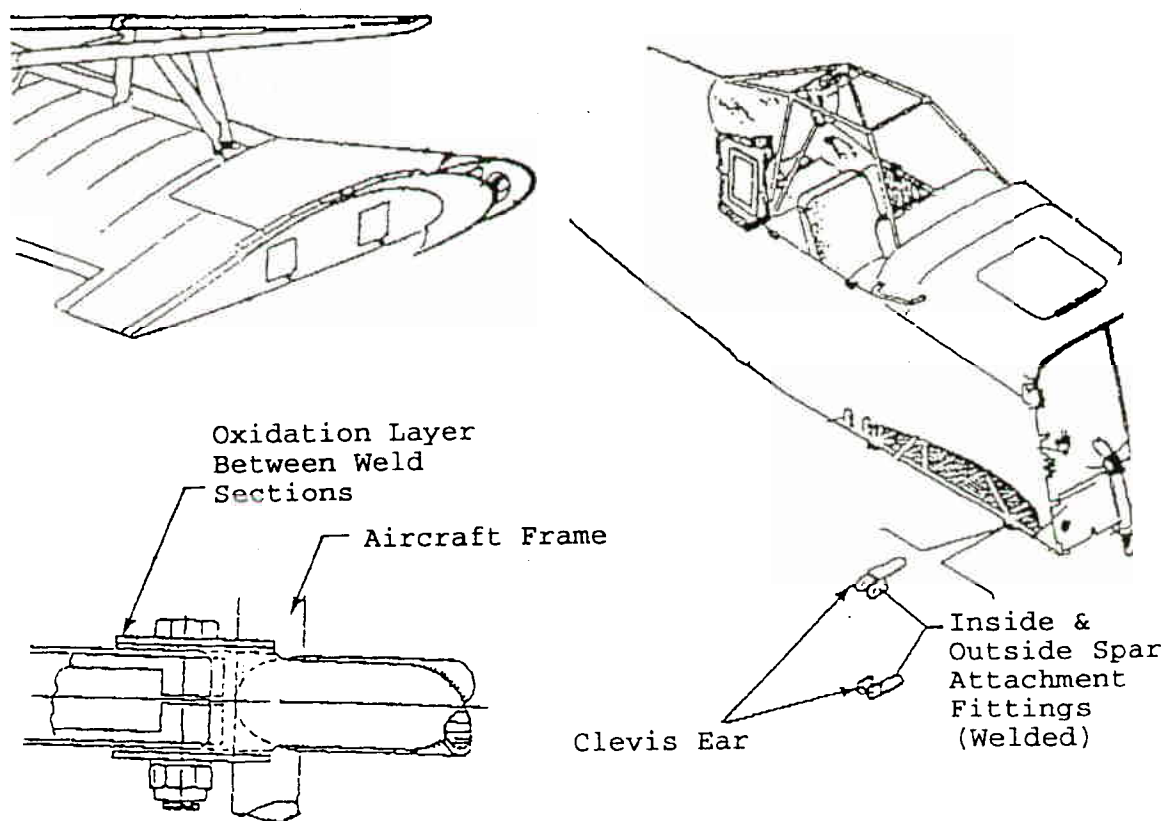
FIGURE 2. LOWER ATTACHMENT FITTING EAR AS ASSEMBLED IN THE PRESENT CONFIGURATION. FIGURE WAS TAKEN FROM AD-93-21-12.

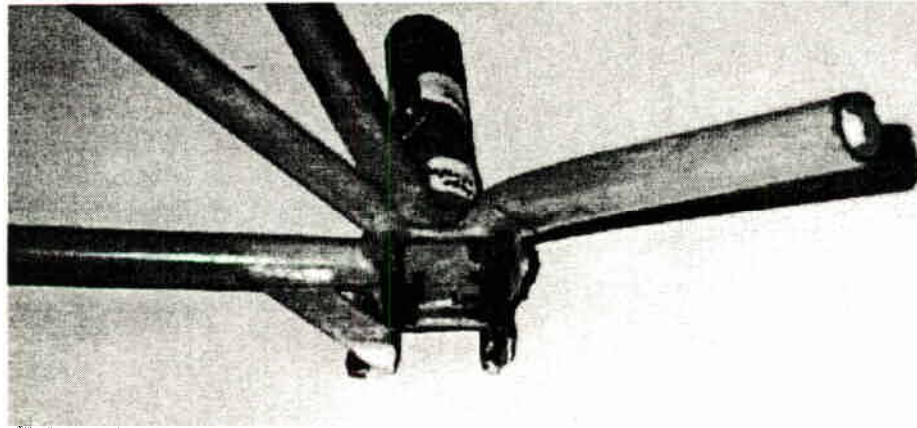
FIGURE 3. PICTURE OF THE FORWARD SPAR FUSELAGE ATTACHMENT CLUSTER CUT FROM AN ACCIDENT AIRPLANE IN ALABAMA.

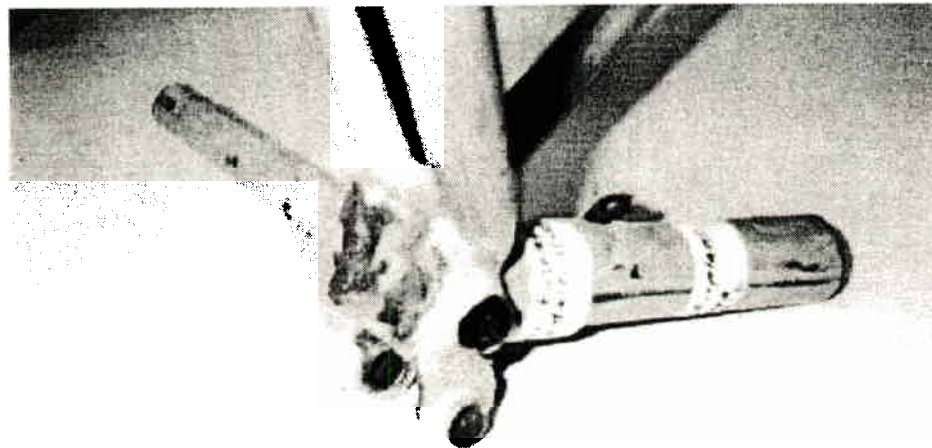
FIGURE 4. SIDE VIEW OF FIGURE 3 THAT DISPLAYS THE EXTENSIVE CORROSION OF THE FITTING EARS.

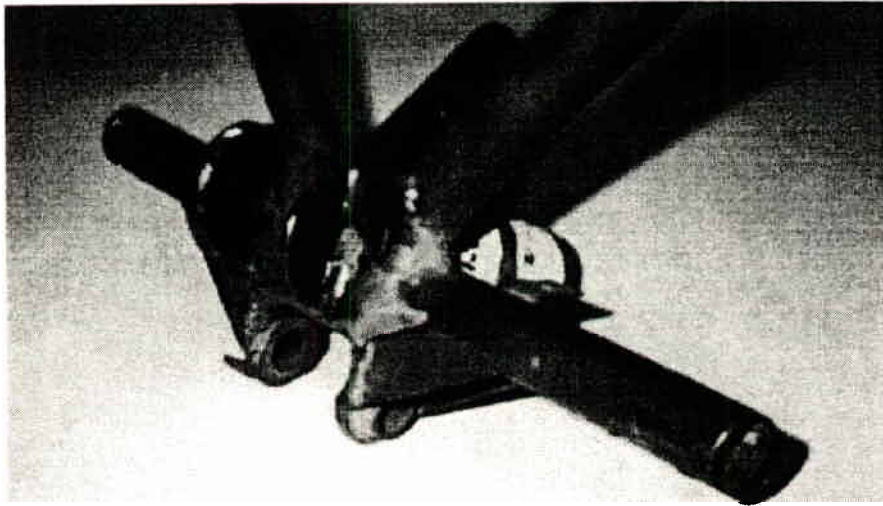
corrosion on both ear fittings. Half of one ear was removed by a bandsaw to reveal the inner layer corrosion shown in figure 6. Sample 3 was a forward spar fuselage attachment cluster used as a blind sample to develop the inspection techniques. It was not known if corrosion existed between the inner layers. Sample 3 is shown in figure 7. The AANC staff performed both radiography and ultrasonic inspections on the spar cluster assembly. Test setup, calibration, and inspection techniques are described, and findings from each technique are stated.

FIGURE 6. SAMPLE 2 - FORWARD SPAR FUSELAGE TUBULAR ATTACHMENT CLUSTER FROM A PA-25 AIRPLANE. NOTE: HALF OF ONE EAR WAS REMOVED BY A BAND SAW. THE DARKER AREA IS CORROSION.
